Attention Mr.: Victor Retamal
Reference: Report Services Repair box Equipment:
Equipment: Finnoy Propeller Box. G 50 FX. (transmission for propeller speed control)
Vessel: Seidvag
Request 1: Box presents angle and motion problems.
Request 2: Solve pressure and temperature control problems
Service port: Puerto Montt Forward.
Circulated by: Guillermo Muñoz
Document type: Technical Report.
Work Dates: August 18/22, 2019.
Reference No.: 18082019.1706.
Propulsion Box Service: Seidvag
The services done on: August 18-22, 2019

Maintenance and full overhaul of Finnoy Propeller Box. G 50 FX. (transmission for propeller speed control).

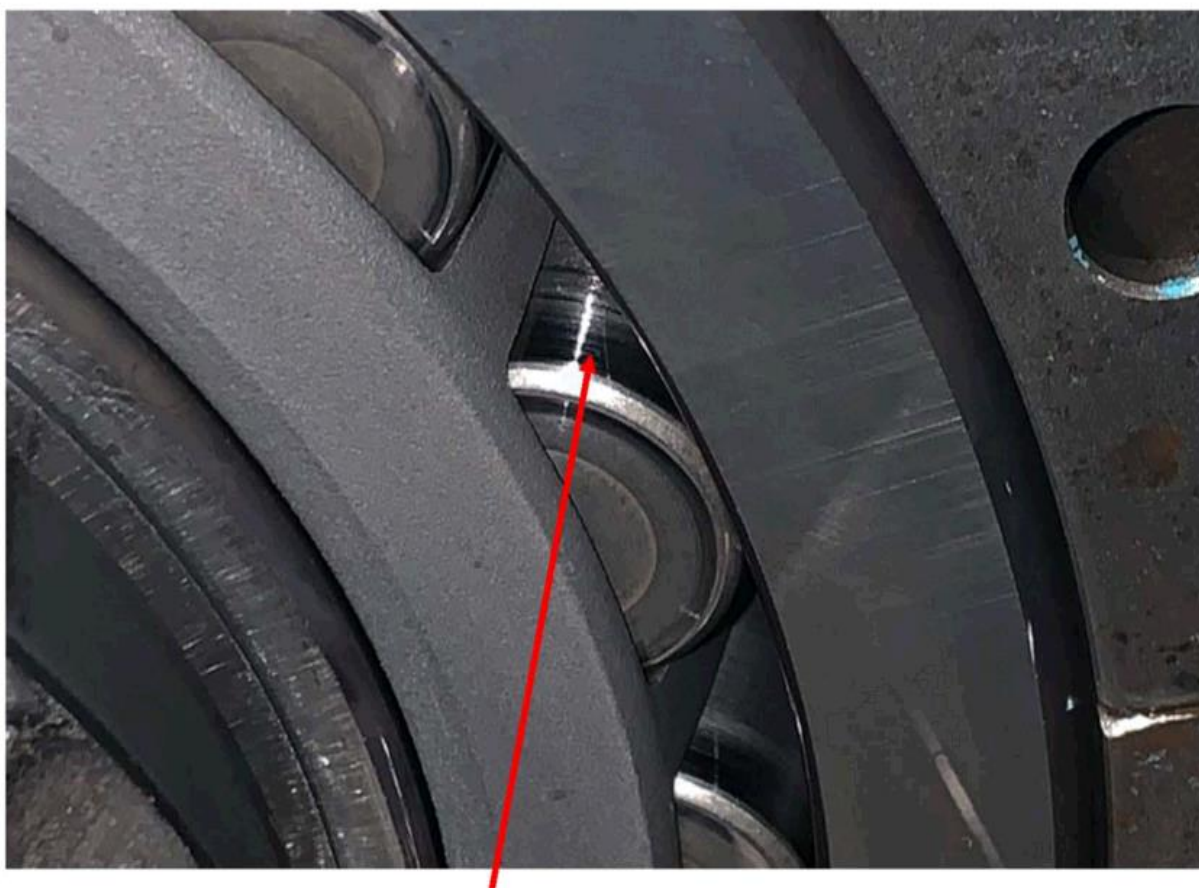
Picture 1

Bearings with raceways and rollers, damaged by marginal lubrication caused by working with oil contaminated with water resulting with excessive wear and increase in operating temperature. It looks like Polytron MTC stopped this destructive process.

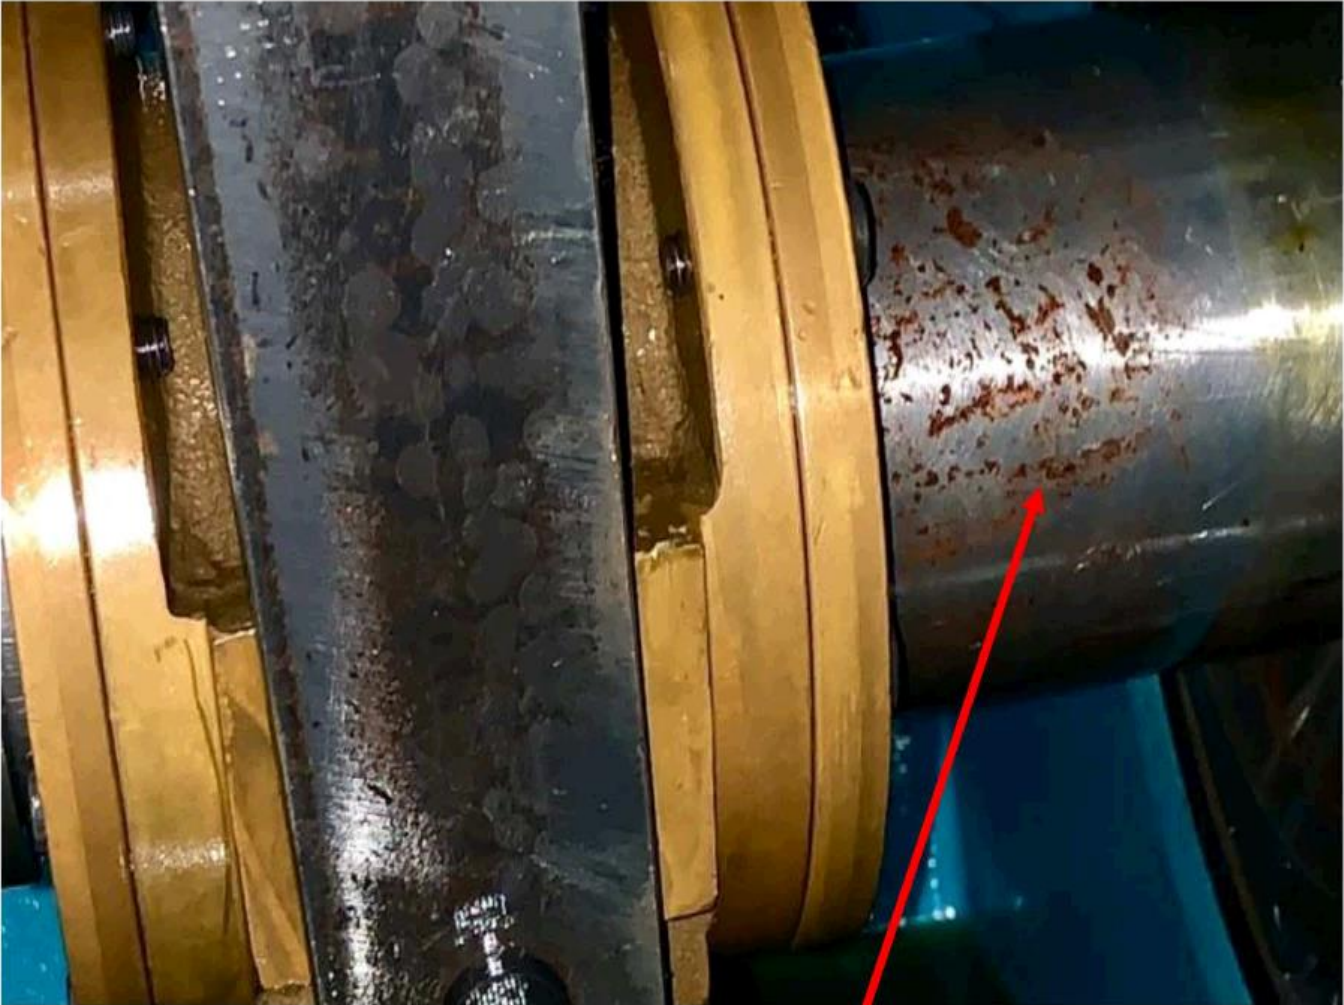
Picture 2

(Status of the servo piston bar, which is part of the main servo piston of the oil distributor that controls forward and reverse motion, had mechanical damage and rusted surfaces in the area where it "runs." Torn off small pieces of metal as a result of micro-seizures, caused most likely by water contamination. This damage cause difficulty in angle control of the blades and increase in operating temperature.

Looks like that in spite of this damage, as soon as Polytron was added, this process stopped, and the operating temperature went down.

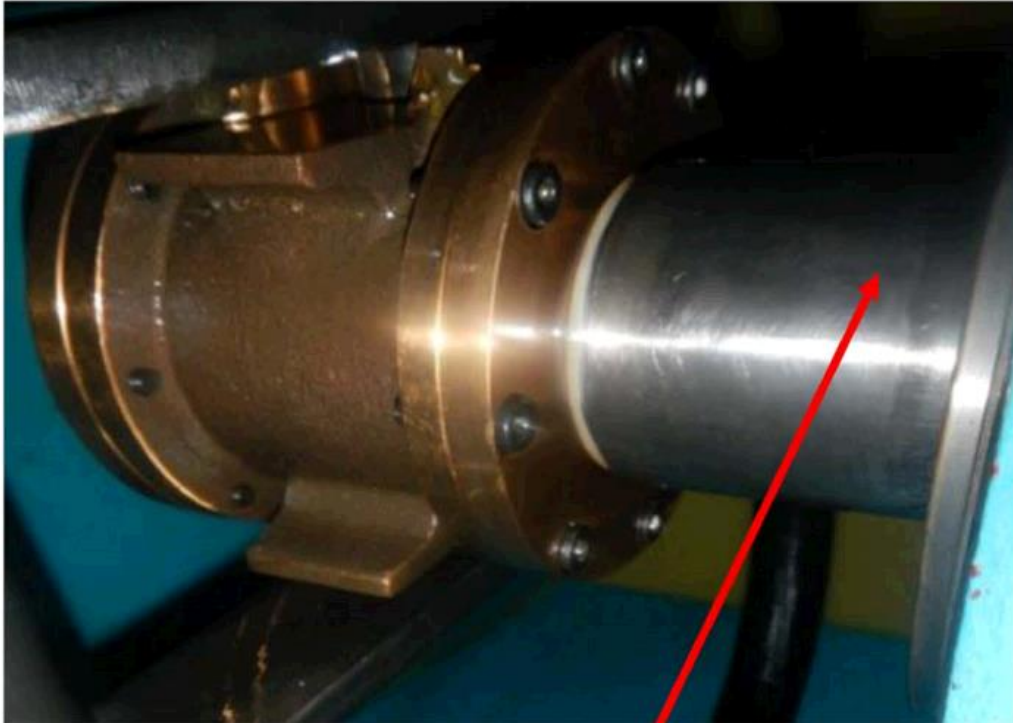
Picture 3

For comparison,
the initial condition of the "bar" when mounted in previous repair (overhaul) of the box.

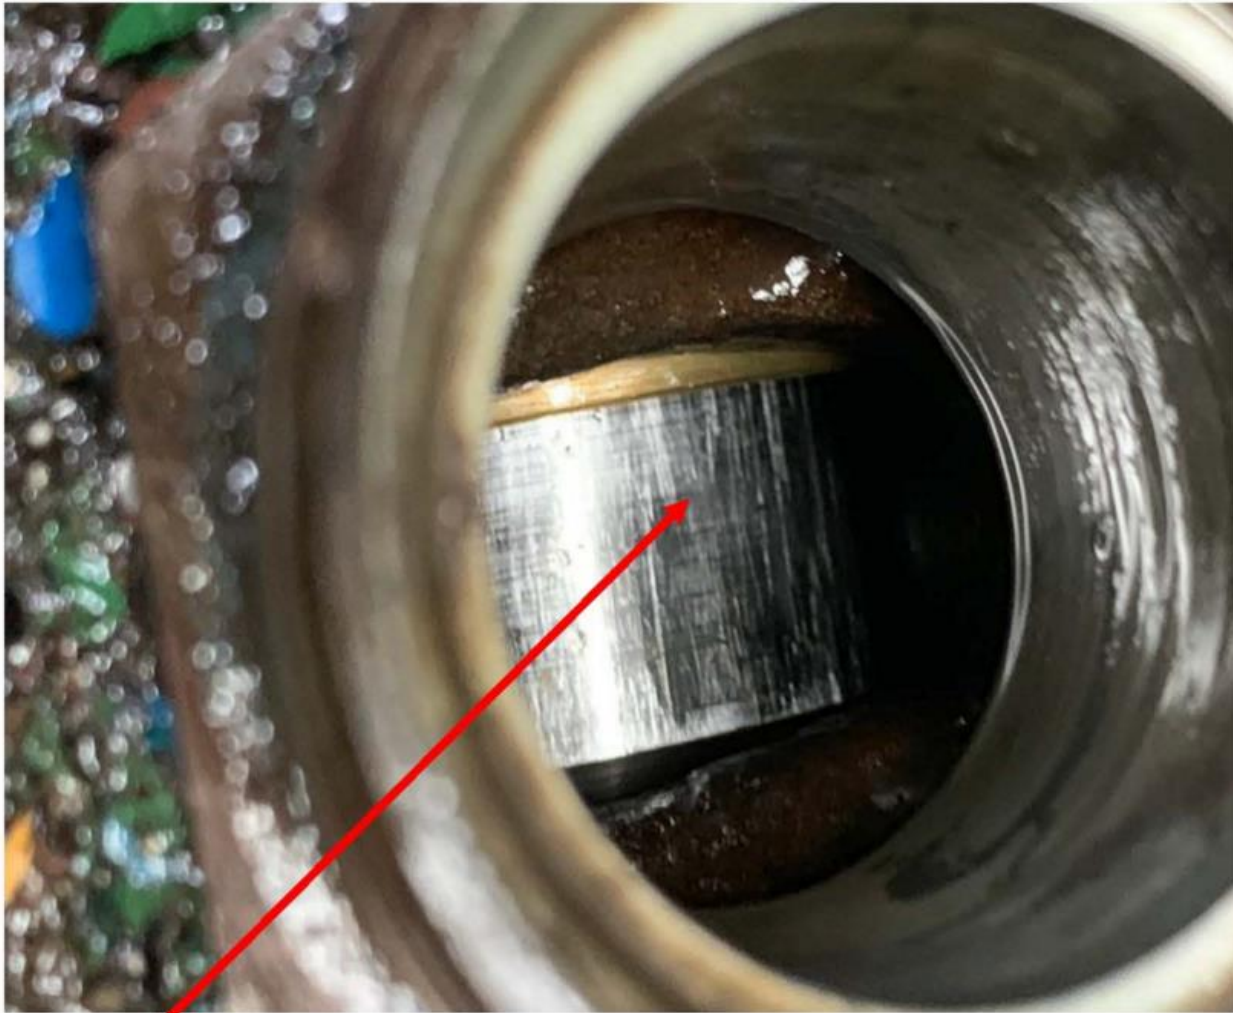
General pressure control piston.

Many large deep scratches were observed, because of poor lubrication due to water contamination.

Valve pistons have to remain polished, in order to allow valve to work properly.
